Landslides and morphological characterization in the Serra do Mar, Brazil

H.C. Dias, V.C. Dias & B.C. Vieira

Department of Geography, University of São Paulo, São Paulo, Brazil

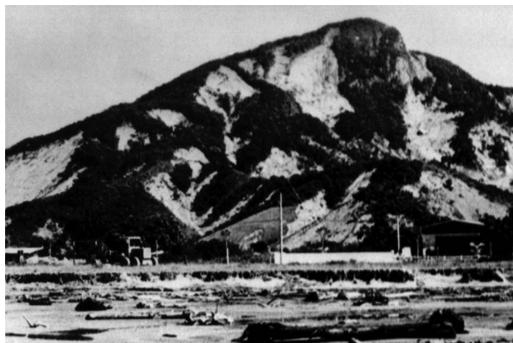
Figure 2. Landslides in steep slopes Caraguatatuba, in 1967. Source: Public Archive of Caraguatatuba.

From the morphological point of view, slope angle can influence on the slope stability, once as the angle increase, the soil or unconsolidated materials tension also increases. Thus slopes with angle above 30° are more susceptible to landslides

(Fig. 2). The curvature can indicate areas with preferential accumulation of rainfall, which turns this parameter very important in the evaluation of the slopes dynamics, since the occurrence of concave

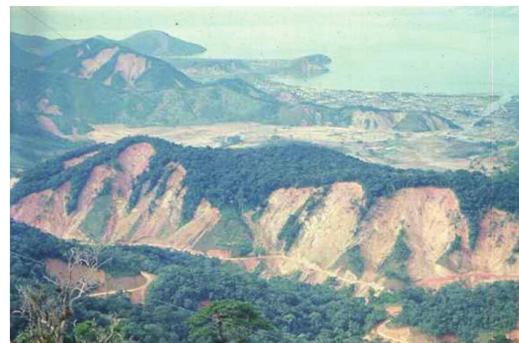
Figure 3. Landslides occurred in concave slopes in 1967. Source: Marcelo Gramani (personal archive).

slopes (Fig. 3) indicate areas where soil saturates faster than in other curvature, triggering runoff and consequently influencing directly in the occurrence of landslides (Selby, 1993).

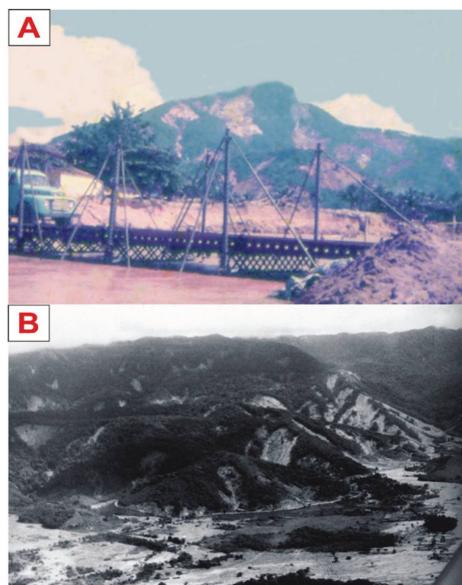
Figure 5. Landslides in Caraguatatuba, 1967. A: Jaraguá Hill and B: Aerial view of the landslides. (Source: Public Archive of Caraguatatuba).

The 1966/1967 summer rainstorms provoked one of the biggest catastrophic events of Brazil related to the occurrence of mass movement. It was characterized by rainfall above average in a short period time (584.8 mm / 48 h). Material from the landslides reached the streams and the huge water volume transported them toward the urban area, resulting in several damages to the population and local economy, destroying residential and commercial areas, highways and industries (Fig. 5) (Cruz, 1974).
